Ak-Chin Indian Community surface water treatment plant

Long View

Indian community invests in award-winning treatment plant

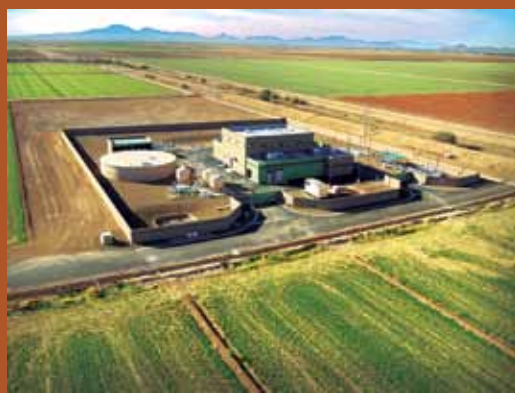
An aerial view of the Ak-Chin Indian Community surface water treatment plant, taken from an ultra-light aircraft by Dave Weesner, superintendent for PCL Constructors
